# Examination of the Meng 1/32 Fokker F.I/Dr.I Triplane

Michael Turner

Version 2.0, April 2021

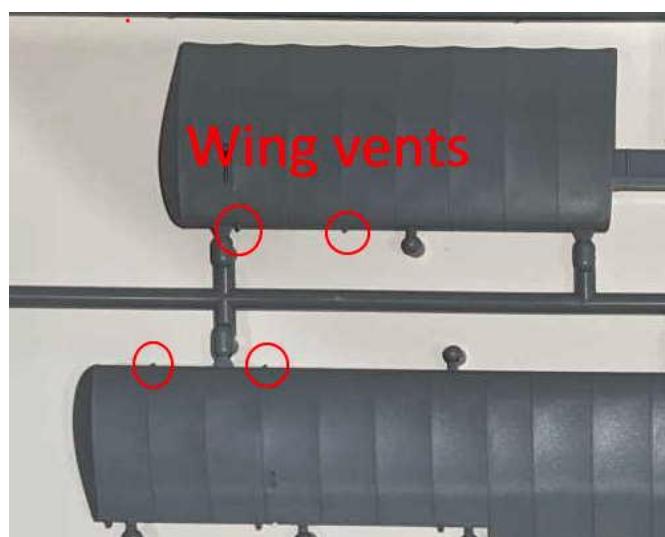
Figure 1: Wing vents

As noted above, after 28<sup>th</sup> November 1917, aircraft were fitted with wings that included vents near their wingtips. Although not referenced at all in the instructions, the kit wings have both sets of these vents moulded on as shown in Figure 1.

As noted above, not too long after the aircraft entered into service wing vents were added to wings. Some of these modifications were retrospective while some aircraft received new build wings, as did all new production aircraft. The Kagero site [1] states that early aircraft had the vents at the 4<sup>th</sup> rib in from the wing tip and later aircraft had the vents at the 2<sup>nd</sup> rib, but that is not supported by the photographic evidence.
